Bioengineering in Four Mile Run, Virginia

by Jay West, Save Our Streams Program, Izaak Walton League of America, Inc.

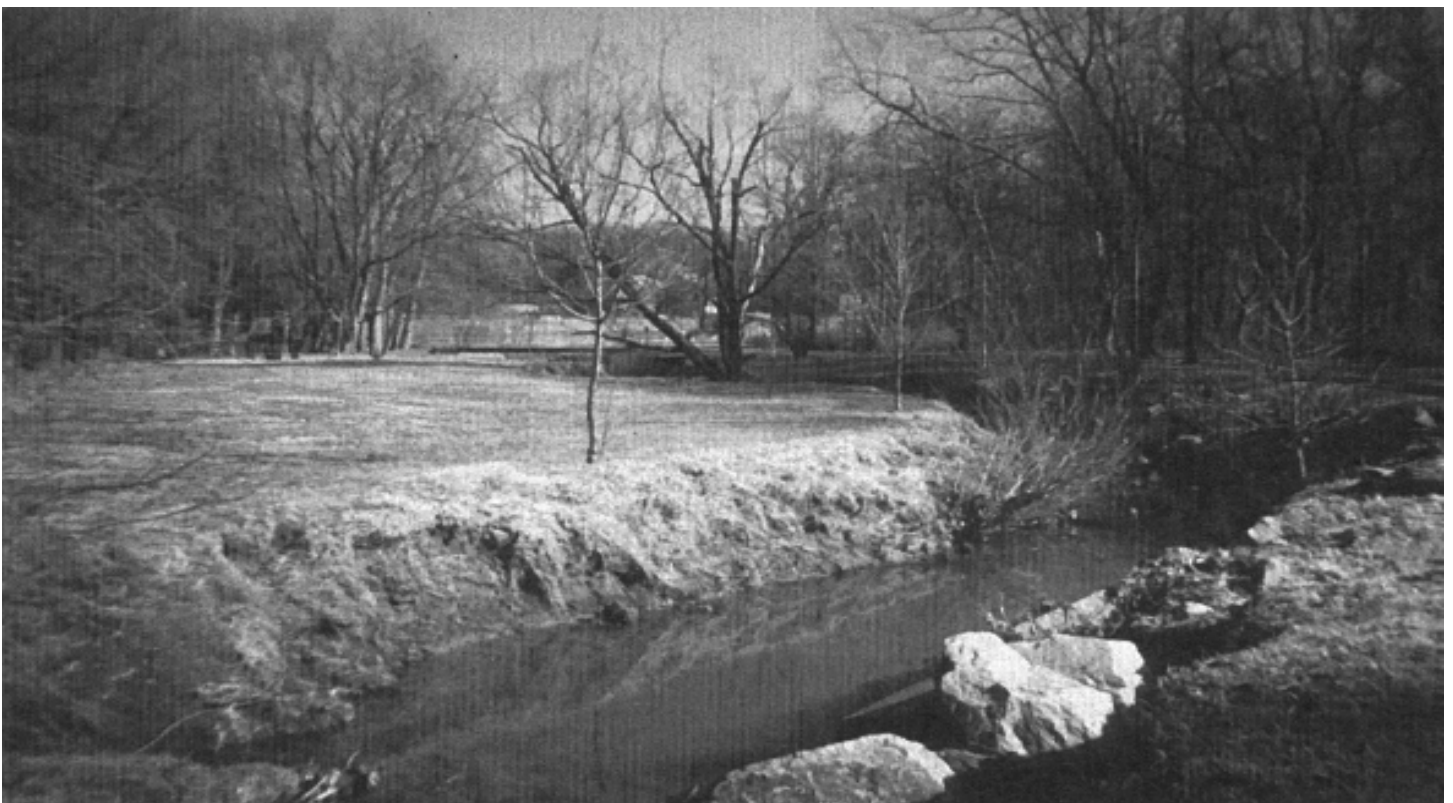
tat are poor. The remaining natural channels exhibit significant bank erosion, with vertical banks ranging from three to eight feet tall.

Figure 2: Before Restoration, the Site Was Characterized by Actively Sloughing, Vertical Banks

The project began in February 1994. The concept for bank stabilization was to employ bioengineering on the inside of a shallow bend. (An earlier project had placed rip-rap on the outside of the bend where erosional energy was greatest.) The bioengineering treatment involved regrading the bank to achieve a more gentle slope (2:1 horizontal to vertical.) Two shallow trenches were constructed parallel to the stream on the bank contour (see Figure 3). Fascines or bundles of dormant willows and dogwood were then placed in trenches along the contours of the bank. Each fascine was about seven feet long, with the rooted ends facing upstream.

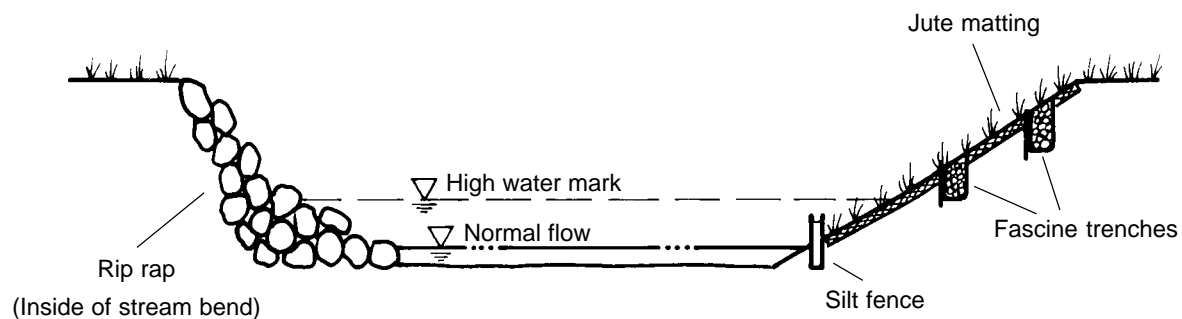
Figure 3: Bank Stabilization Technique Used at Four Mile Run

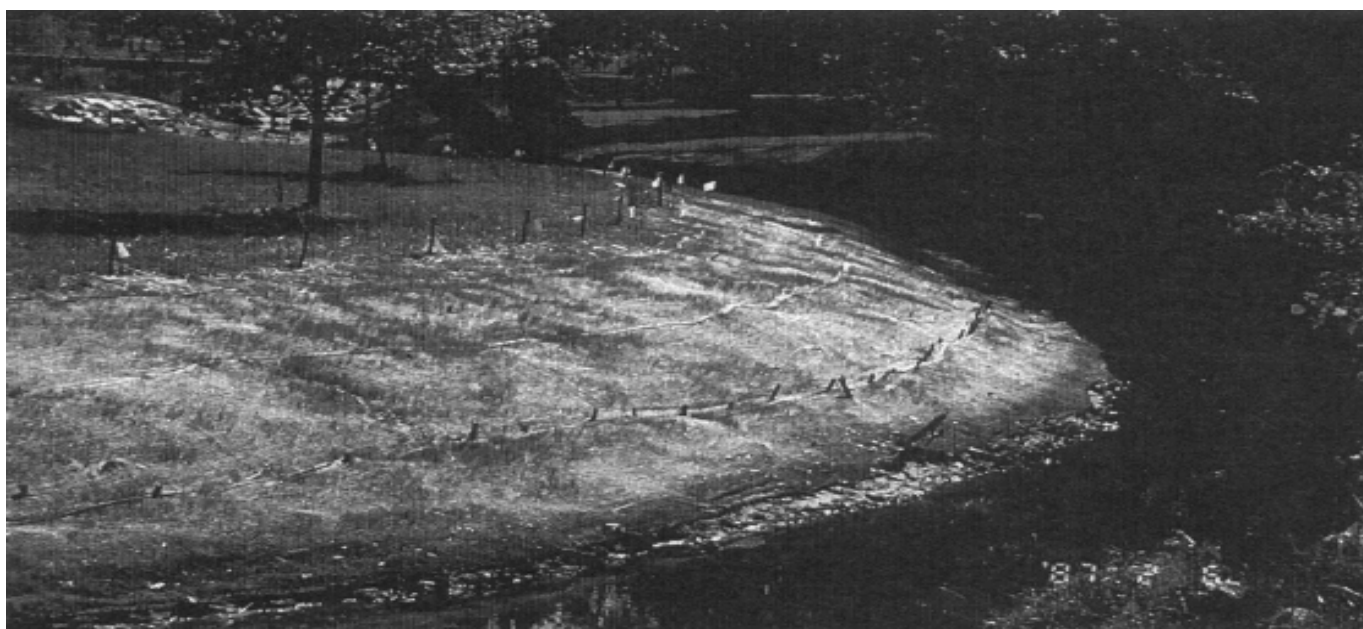
The site has been frequently inspected to see how well it holds up to erosive stormflows. Figure 43.4 shows the site two weeks after installation, shortly before the grass had become fully established. Within 10 weeks, the willows and dogwoods had sprouted, and a thin layer of fine silt had been deposited over the erosion control fabric. The growth and sprouting of the fascines was not as great as expected during the growing season, possibly because the fascines were not completely dormant at the time of planting. Overall, plant growth was relatively sparse, and some weeds had invaded the site. After four months, some erosion was reported at the toe of the bank, and the designers considered placing a rip-rap layer to protect the base of the slope. Inspection during the second growing season has indicated greater sprouting success for the willows and dogwoods.

Figure 4: After Restoration: Two Weeks After Installation of the Plant Materials, Grass Started to Sprout
