### Enhancing Environmental Protection and Flood Resilience: HEC-RAS Modeling at the Mattawoman WWTP

Jessica Krueger, PE
Project Manager
RK&K

Kaitlyn Morrow, PE
Project Engineer
RK&K

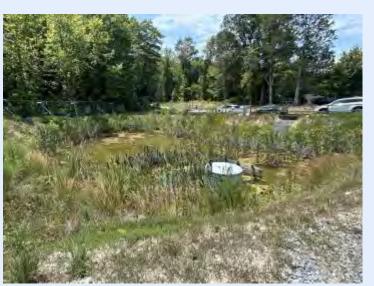
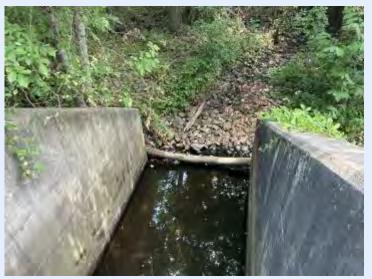
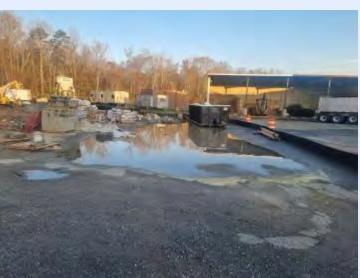
March 2025

### **WWTP Flood History**

- Constant issues with on-site drainage
- Minimal elevation change across WWTP
- Increased Development Upstream
- Bordered by Mattawoman Creek and Unnamed Tributary

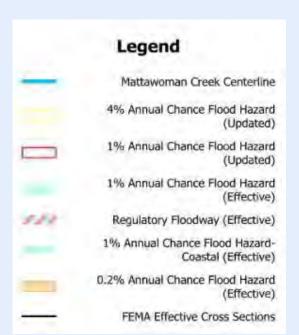
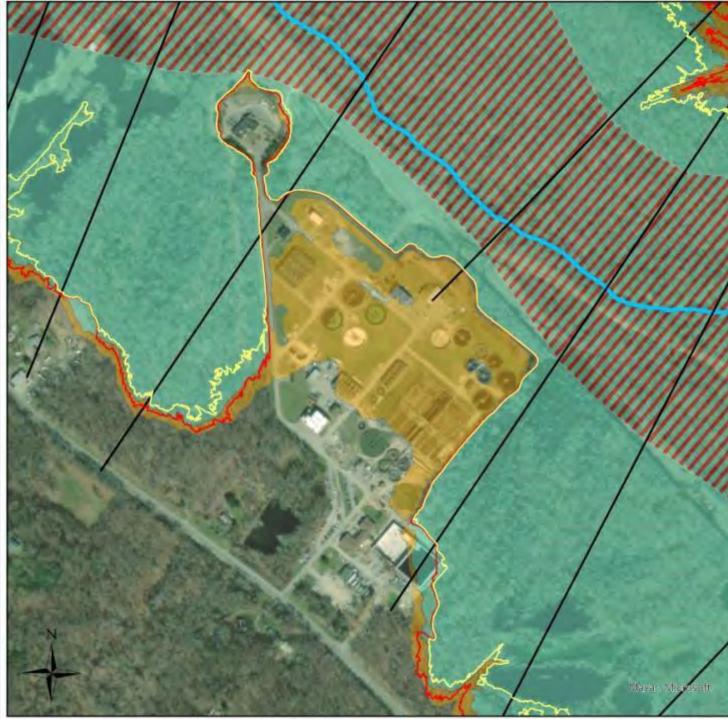
Mattawoman Creek Updated Existing (2024)

### **Existing Hydrology**Results:

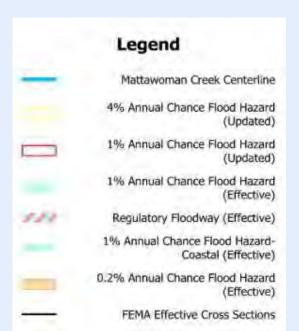
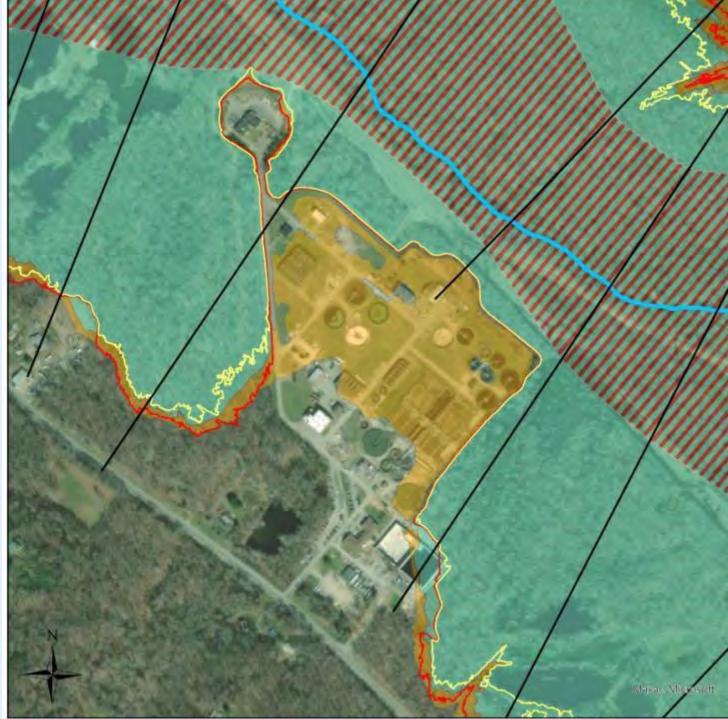
Mattawoman Creek Potential Future (2100)

### **Existing Hydrology**Results:

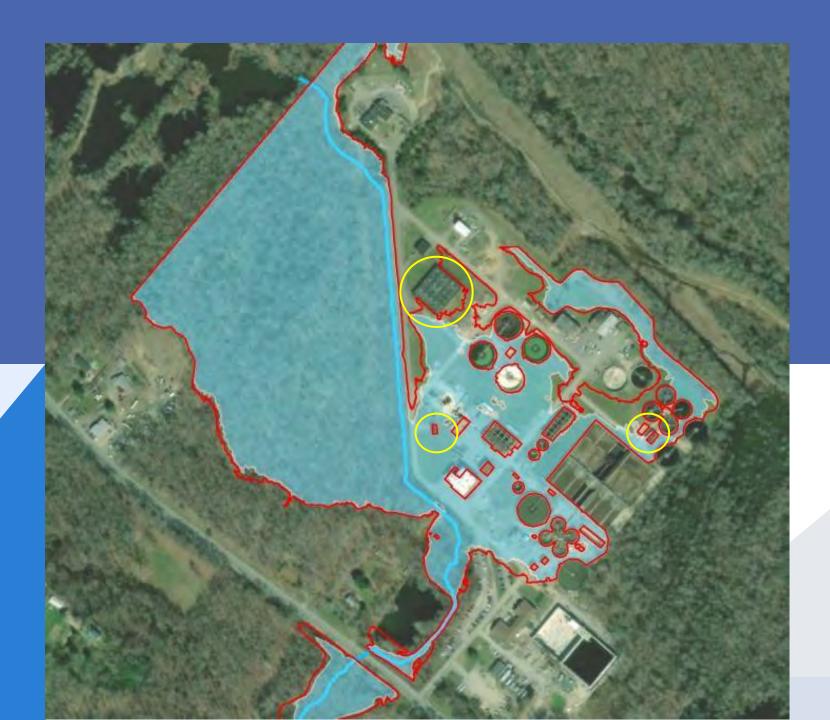
UNT to Mattawoman Creek

### **Existing Hydrology Results:**

**UNT HEC-RAS Cross Sections**

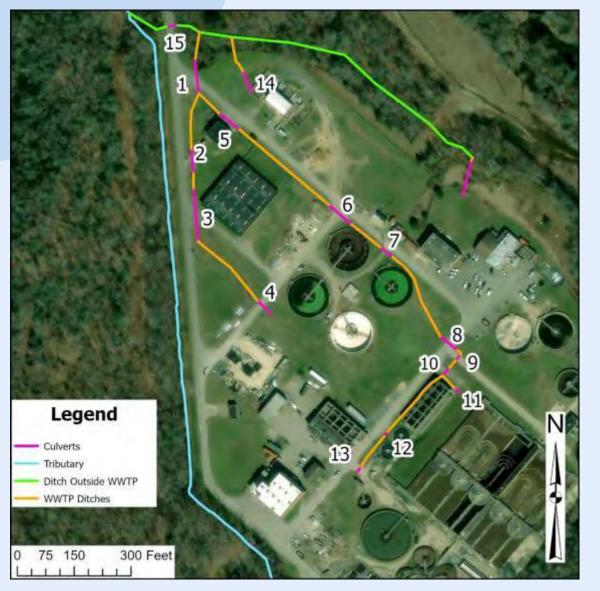
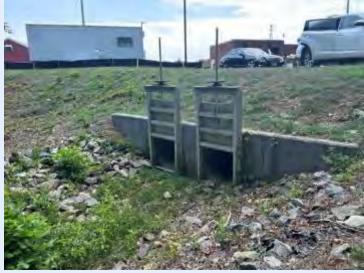
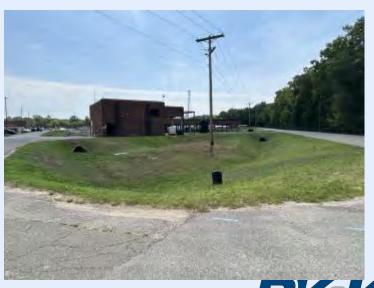
### **Storm Drain Network Improvements**

- 1) Perform inspection and maintenance of the existing sluice gates on site.
- 2) Perform maintenance on access drive culverts throughout the WWTP.
- 3) Culvert replacement of the existing box culvert under the Potable Well Building driveway, minimal access drive grading, and dredging of the downstream tributary.
- 4) Acquire portable pump systems to be deployed during tidal impacted flood events.
- 5) Inspect and fortify the existing berm between the WWTP property and Mattawoman Creek.

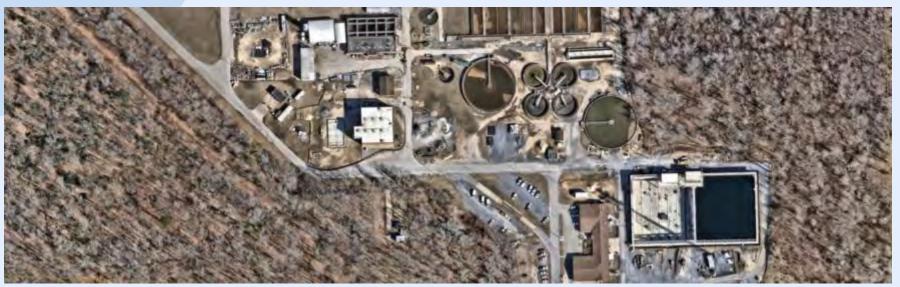
### Potable Well Building Driveway Improvements

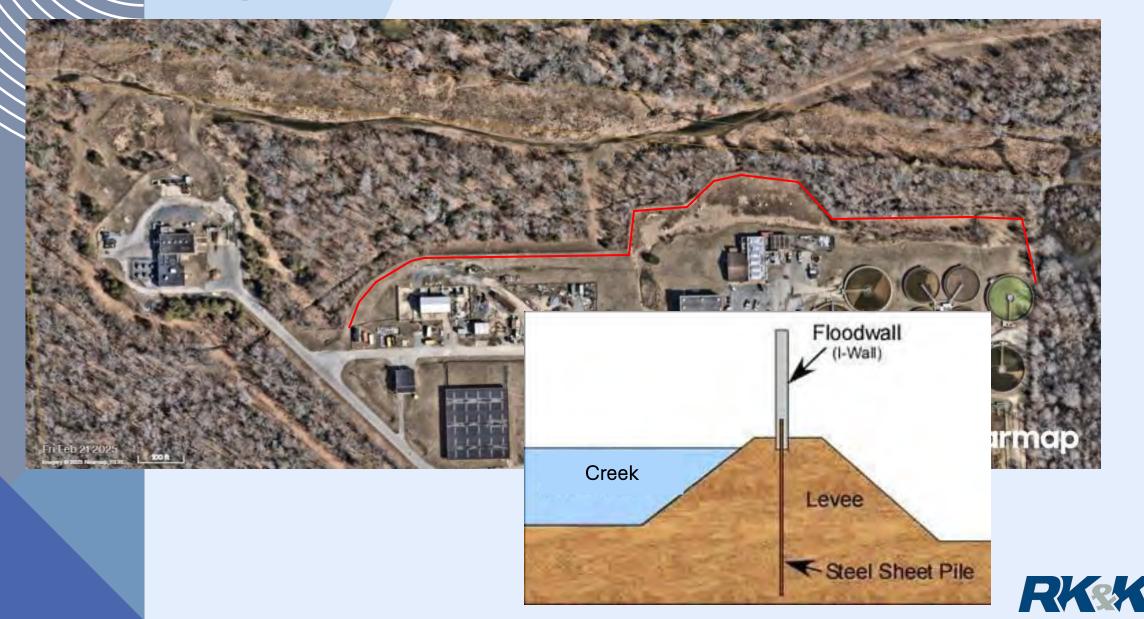
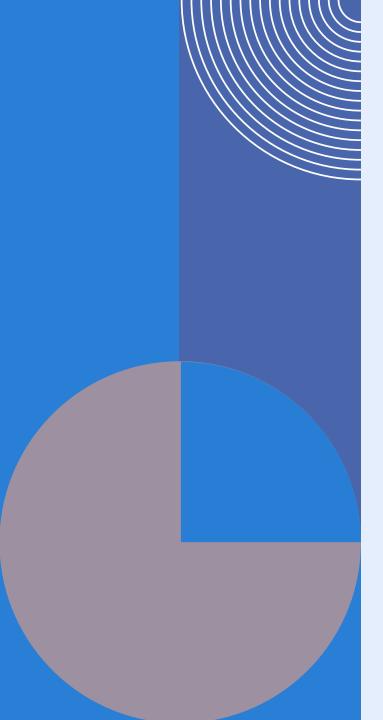
### **Inspection & Fortification of Berm**
